Manhole Inspection Summary

Manhole # S47AA_001MH

Inspection ☐ Is Incomplete Rating: **3) Fair**

Location Address: **Madison**

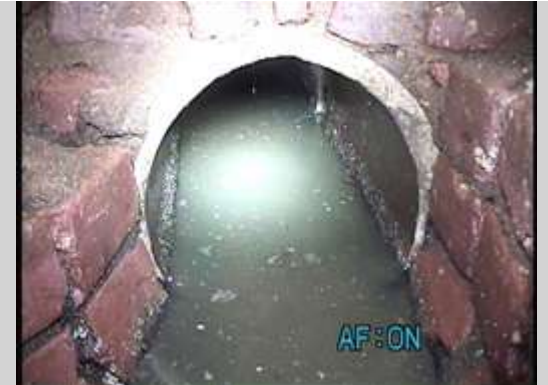
12 O'Clock Outflow

8 in. Circular Gravity Sewer
Pipe Out @ 12 O'Clock

Infiltration: **None** Pipe Seal Cond: **Sound**

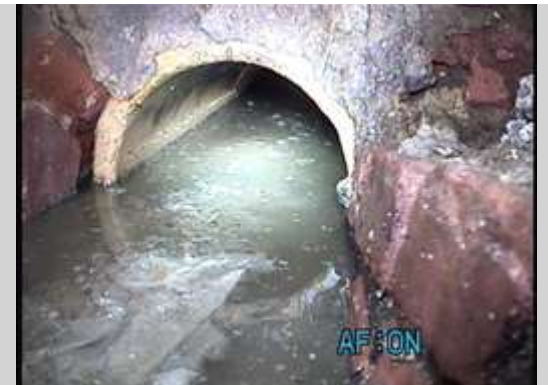
9 O'Clock Inflow

8 in. Circular Gravity Sewer
Pipe In @ 9 O'Clock

Infiltration: **None** Pipe Seal Cond: **Sound**
